SANTI GULLY

GULLY STABILIZATION

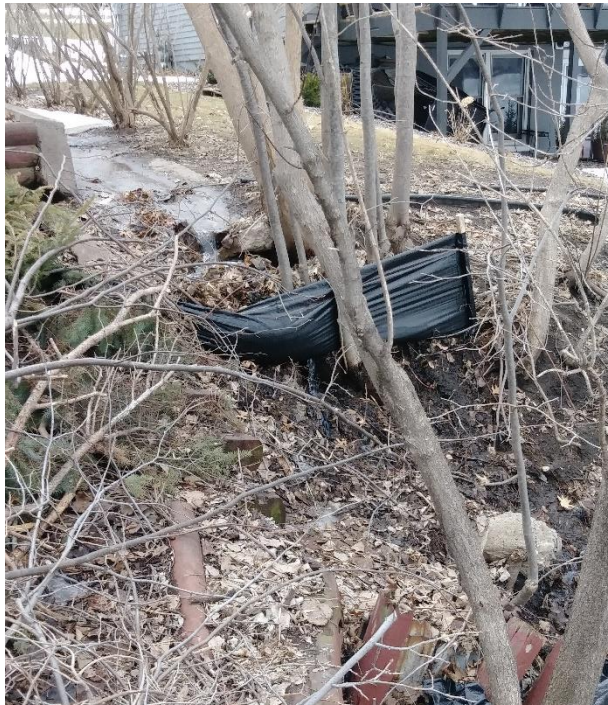
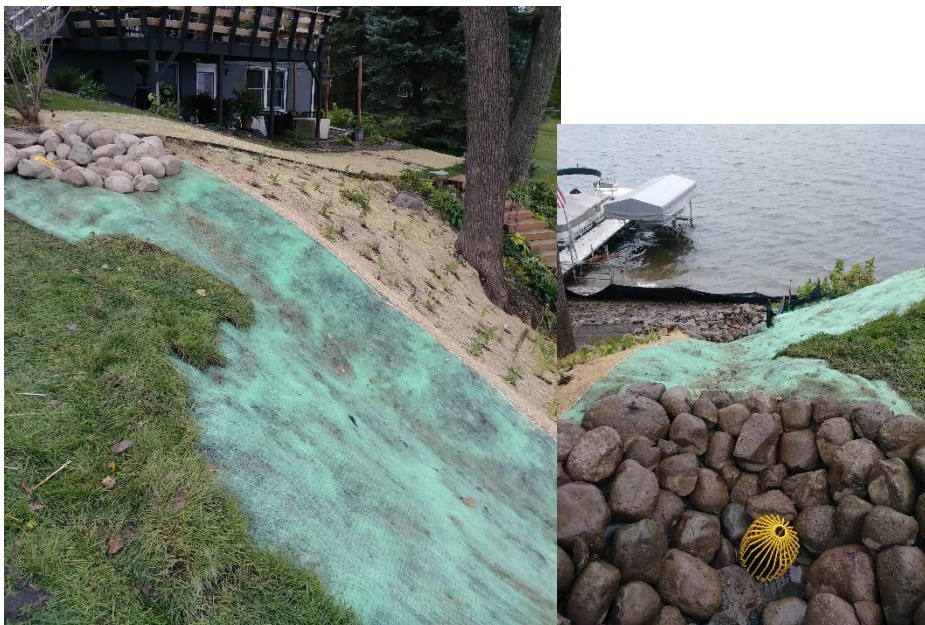
Neighbors on South Center Lake came to the Chisago Soil & Water Conservation District (SWCD) with an eroding gully on their property line in the spring of 2019. The SWCD assessed the gully and determined the best way to keep sediment out of the lake was to install a rate control pipe to carry the water down the steep slope safely. The hillside is also now stabilized with native plants.
