FLADEBOE GULLY

GULLY STABILIZATION – SPIDER LAKE

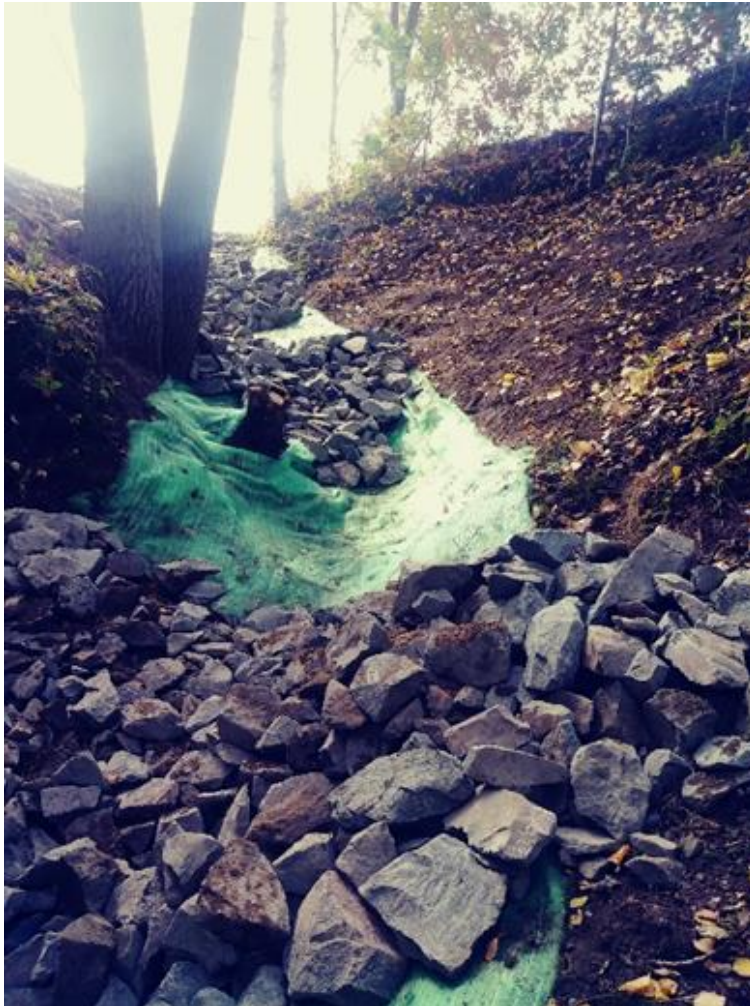
A large eroding gully was stabilized on the shore of Spider Lake in Southern Chisago County. The gully was 8-15 feet deep in places and eroding directly into the lake on moderate and heavy rains. The gully is now stabilized through rock checks, permanent erosion control, and native seedings. The landowners will be responsible for the long-term maintenance of the gully restoration.
