MAPLE STREET GULLY

GULLY STABILIZATION

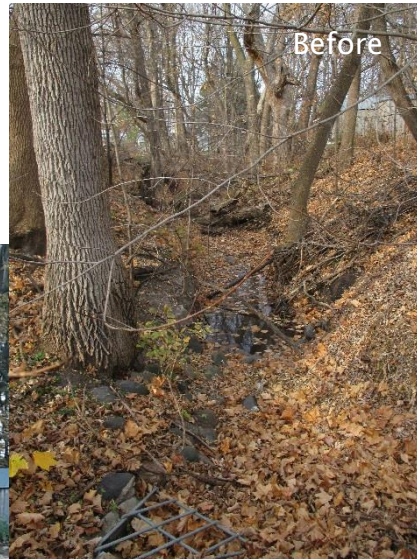
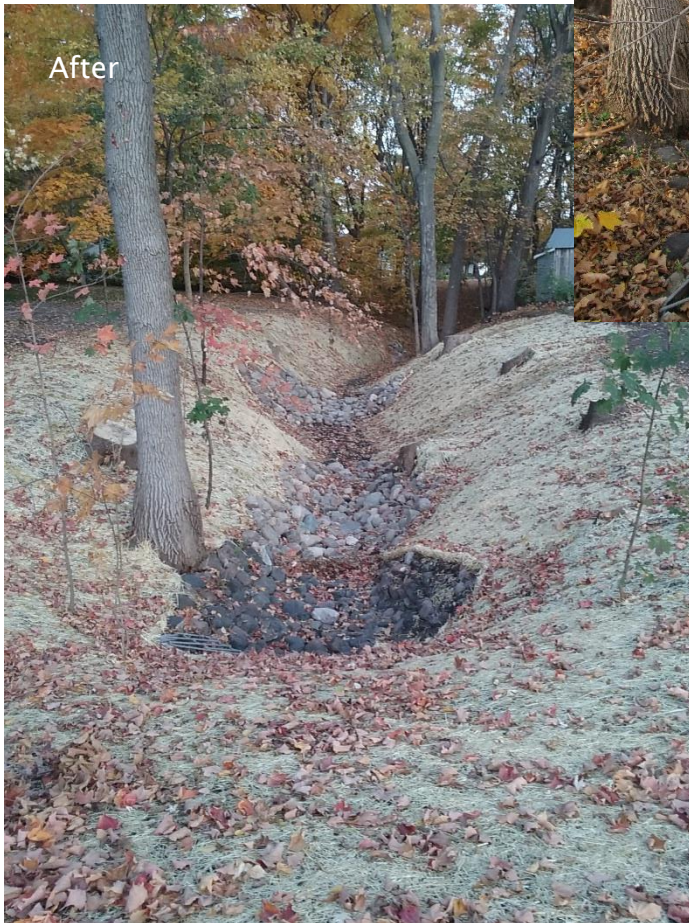
Rock checks and log checks were installed to slow water down as it travels toward the lake. Trees were removed to allow light to reach the bottom of the gully to ensure adequate plant growth. Between the native plants, shrubs, and erosion control blanket – the soil will be stabilized and no longer sluff off into the gully.
